Management of the H-Fracture, Common in Osteoporotic Patients

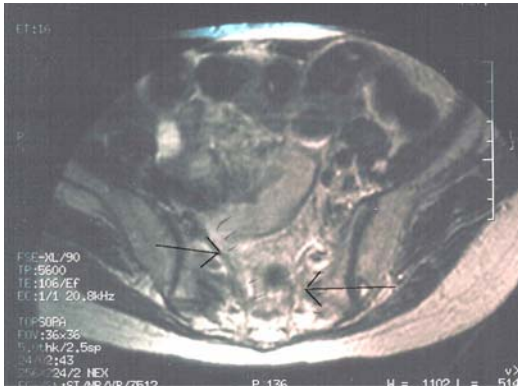
You will see, on the above MRI image that there is the Honda fracture of the sacrum. I have marked the fractures with black italics and arrows.

Treatment has consisted of rest, a pelvic support, and pain medication. There is no displacement of the fracture and the natural course of healing will be allowed.

Plain x-rays, taken in our clinic, failed to show this fracture.

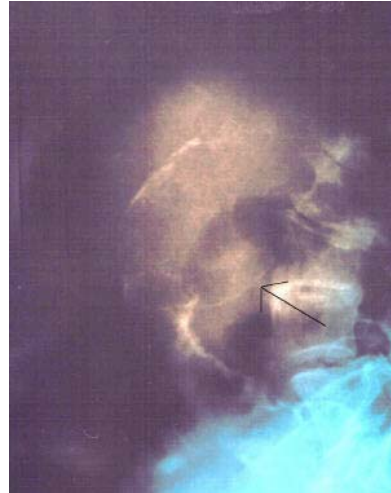
An incidental finding is the large abdominal aneurysm which measures 8x12 centimeters (see arrows). Surgical consultation rendered the opinion to not perform surgery for this aneurysm.
